Manhole Inspection Summary

Manhole # S57M__013MH

Insp Date: **7/3/08 9:46 AM**

Location Address: **rear 3911 hudson st**

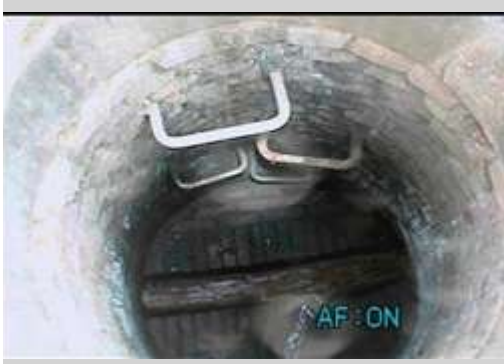
Defect 2

Steps Count: **4** Missing: **0** ☒ **Corroded**

Corroded steps

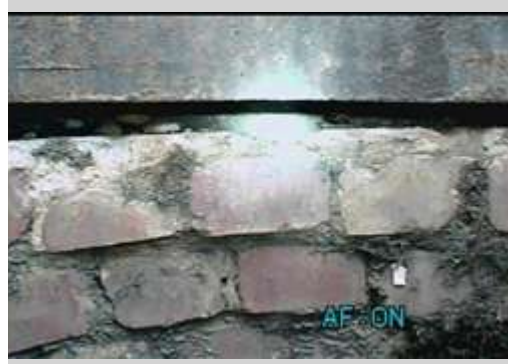
Defect 1

Chimney / Frame Adjustment ☒ Exists Material: **Concrete** ☐ Parged Height: **1.5** (in.)

Condition: ☐ Sound ☐ Cracked ☐ Root Intrusion ☐ Loose Brick ☒ **Deteriorated**

frame adj and chimney cond is deteriorated

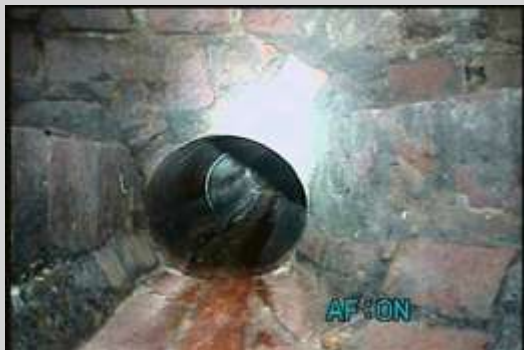
12 O'Clock Outflow

8 in. Circular Gravity Sewer
Pipe Out @ 12 O'Clock

Pipe Material: **Clay** ☐ Pipe Lined

Invert Depth: **8.22** (ft.) Flow Characteristics: **Fast**

Deposits: ☒ None ☐ Mud ☐ Sludge ☐ Debris ☐ Grease

Infiltration: **None** Pipe Seal Cond: **Unknown**

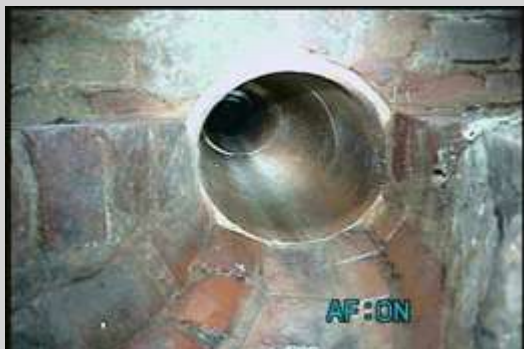
3 O'Clock Inflow

8 in. Circular Gravity Sewer
Pipe In @ 3 O'Clock

Pipe Material: **Clay** ☐ Pipe Lined

Invert Depth: **7.99** (ft.) Flow Characteristics: **Fast**

Deposits: ☒ None ☐ Mud ☐ Sludge ☐ Debris ☐ Grease

Infiltration: **None** Pipe Seal Cond: **Unknown**

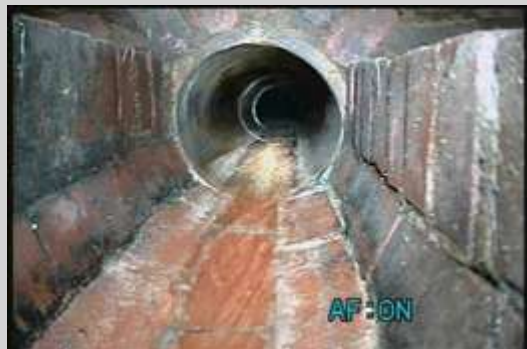
6 O'Clock Inflow

8 in. Circular Gravity Sewer
Pipe In @ 6 O'Clock

Pipe Material: **Clay** ☐ Pipe Lined

Invert Depth: **8.05** (ft.) Flow Characteristics: **Fast**

Deposits: ☒ None ☐ Mud ☐ Sludge ☐ Debris ☐ Grease

Infiltration: **None** Pipe Seal Cond: **Unknown**
